2002 Annual Compliance Report Falls City, Texas, Disposal Site

Compliance Summary

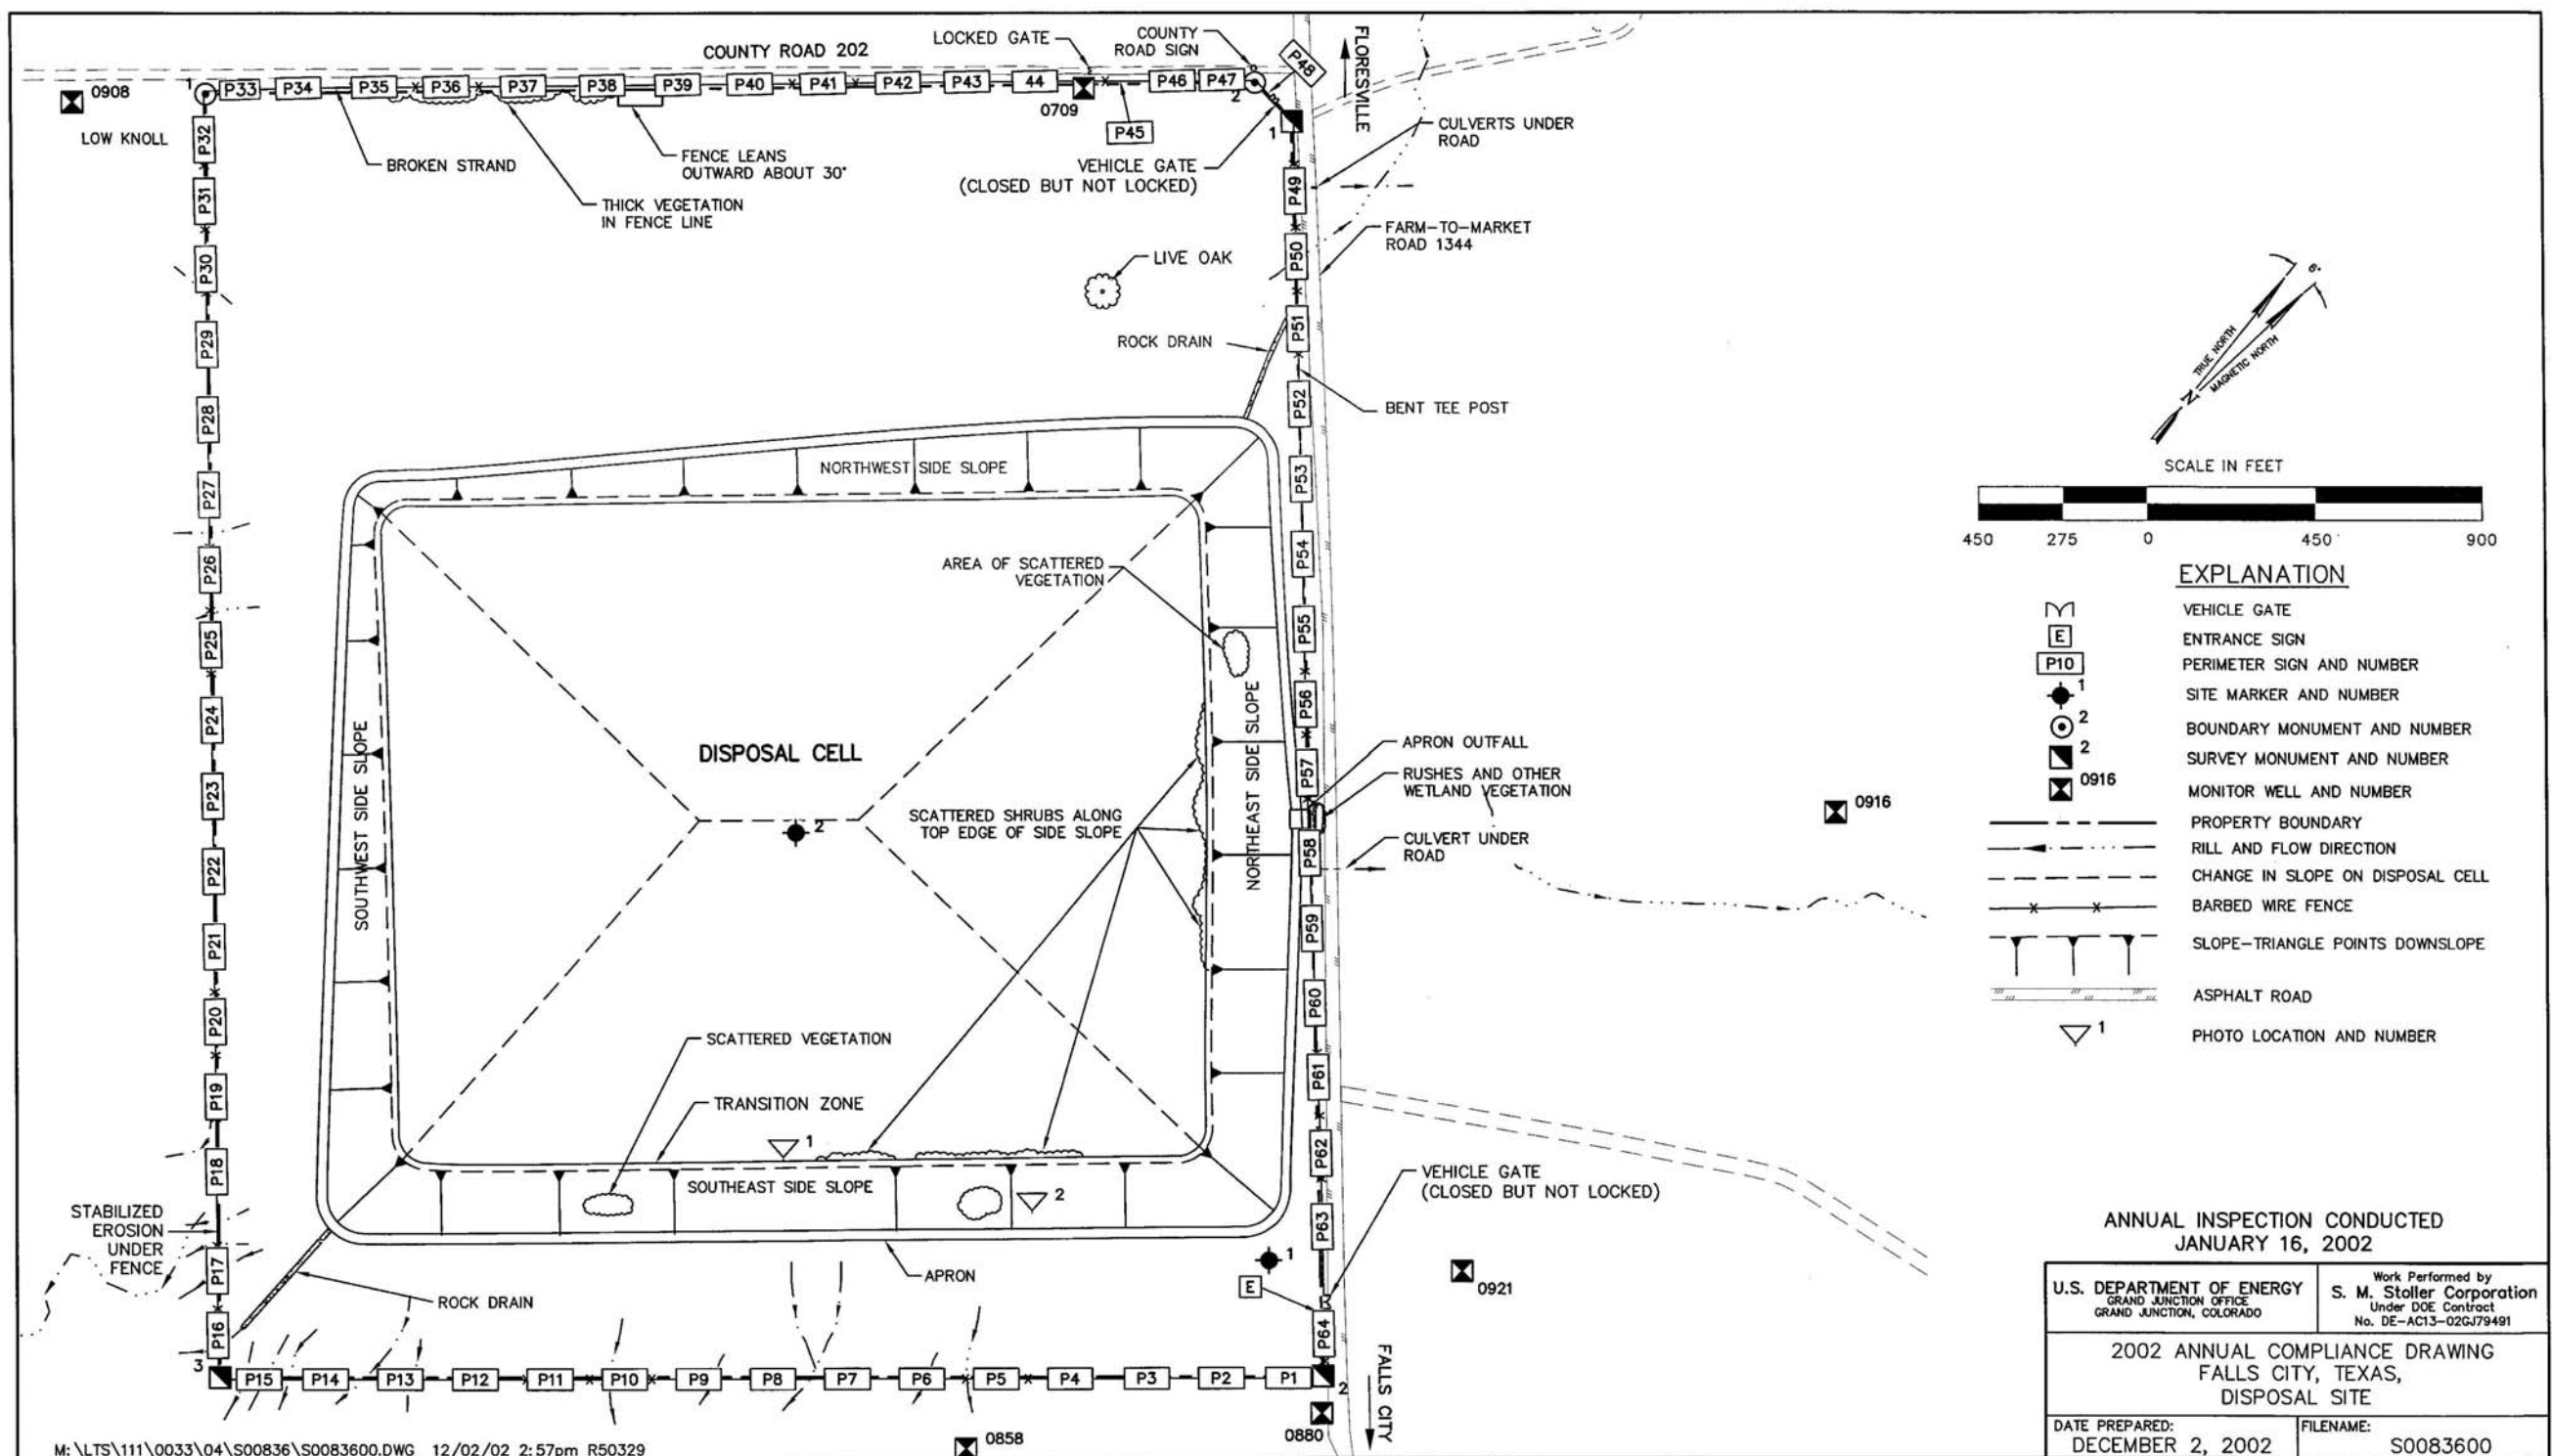
Figure 5-1. 2002 Annual Compliance Drawing for the Falls City, Texas, Disposal Site

The site, east of Falls City, Texas, was inspected on January 16, 2002. Results of the inspection are described below. Features and photograph locations (PLs) mentioned in this report are shown on Figure 5-1. Numbers in the left margin of this report refer to items summarized in the Executive Summary table.

A barbed wire fence set on the property boundary encompasses the site. The fence predates cell construction and is corroding, but generally was in good condition except along the northwest boundary where it leans outward above a steep bank. The fence appeared to be sufficiently stable at this position to keep cattle out, and there was no indication that livestock has ever entered the site. A deer trail was present near perimeter sign P35 where a fence strand was broken.

The entrance sign, located at the main entrance gate, was in excellent condition. There are 64 perimeter signs along the site boundary. All signs were present and in good condition. Perimeter sign P43 had slipped down the post to the ground and was repositioned during the inspection.

Small scattered trees and bushes that had established on the side slopes were mostly absent. Inspectors sprayed the plants with herbicide in previous years and a local farmer was contracted to eradicate the perennial plants. Greasewood and similar species are concerns because they are deep-rooted. Most vegetation was dead including annual plants and most woody species; however, new growth on some previously treated plants was observed (PL-2). Vegetation control will continue on the side slopes.

Water was standing at the north end of the north rock drain, and at the south end of the south rock drain. As noted in previous years, grass is growing in both drains but not in the apron outfall. The rock drains appeared to be functioning properly despite the grass encroachment but will continue to be monitored.

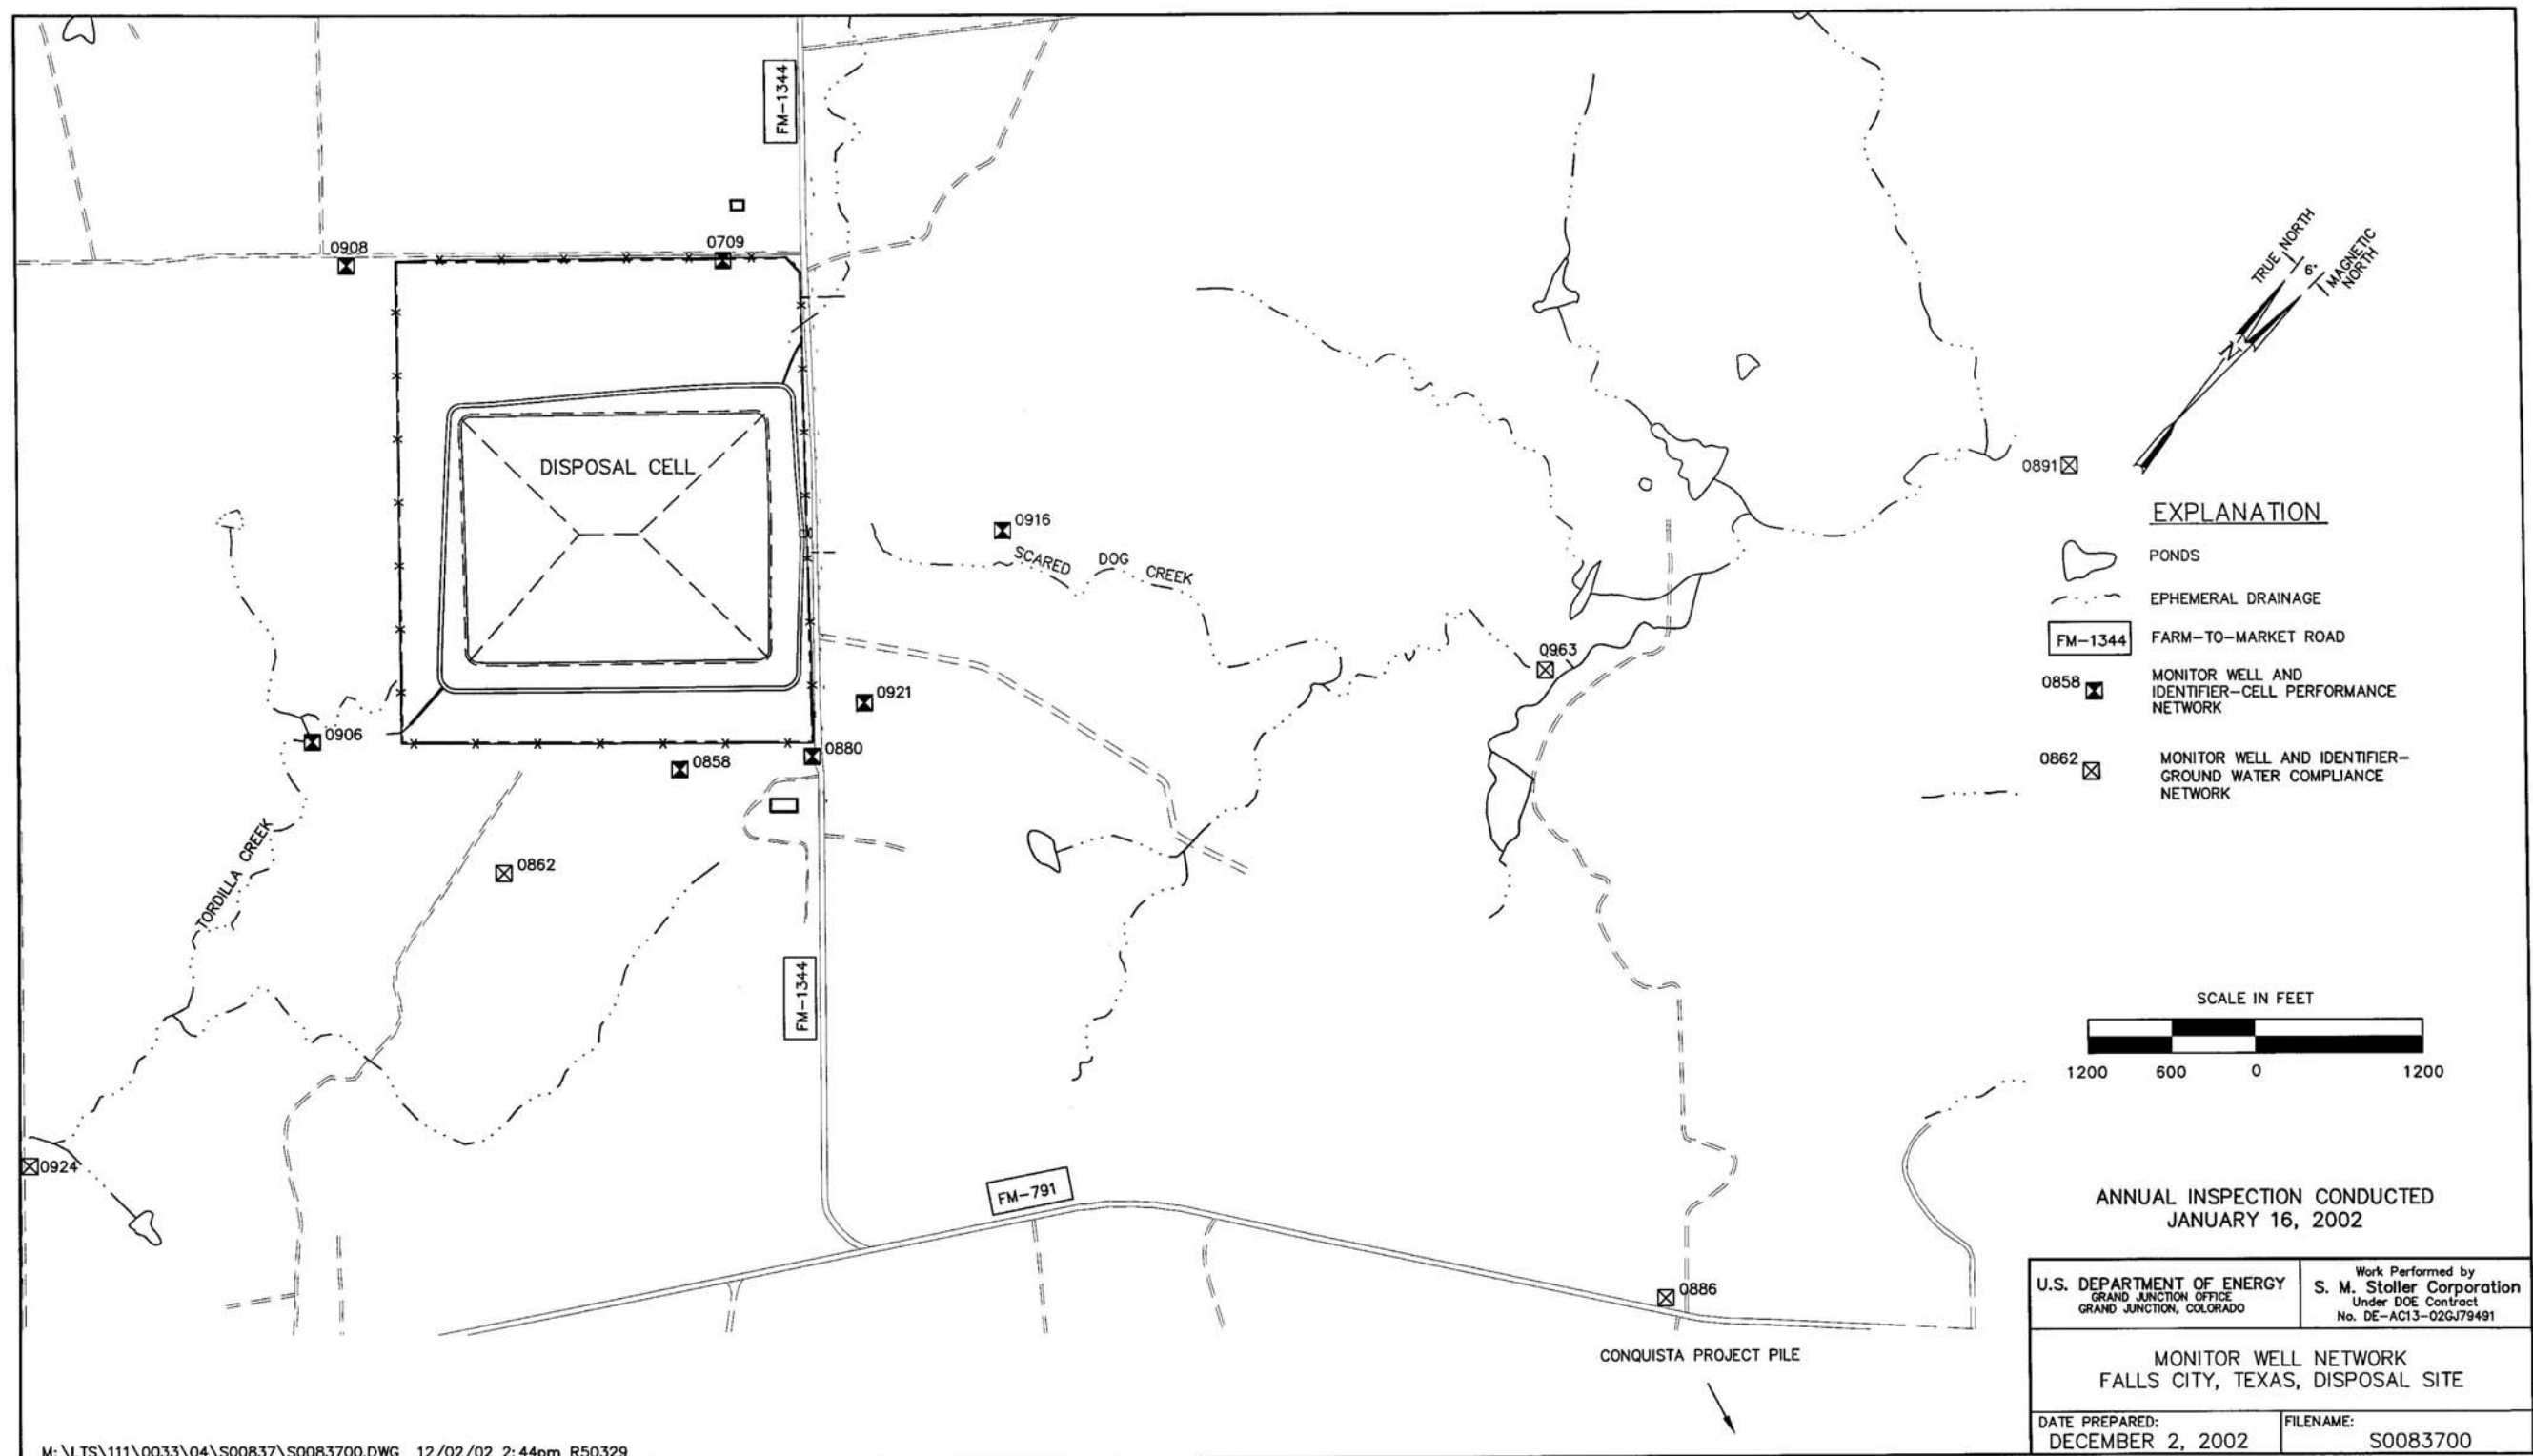
Figure 5-2. Monitor Well Network at the Falls City, Texas, Disposal Site

5B DOE monitors ground water at the Falls City site for two purposes. Ground water is monitored in the uppermost aquifer to demonstrate the initial performance of the disposal cell. DOE also monitors ground water downgradient of legacy plumes of contaminated ground water to ensure that users are not exposed to processing-related hazardous materials. The monitor well network is shown on Figure 5–2.
